T2 Laboratories Explosion Damage Assessment

Presenter: Ben Harrison, P.E., ABS Consulting, 14607 San Pedro Suite 215, San Antonio, TX, 78232, phone (210) 495-5195, fax (210) 495-5134, bharrison@absconsulting.com

Co-Author: Robert Hall, P.E., U.S. Chemical Safety Board, 2175 K. Street, NW, Suite 400, Washington, DC 20037-180, (202) 261-7600, rob.hall@csb.gov

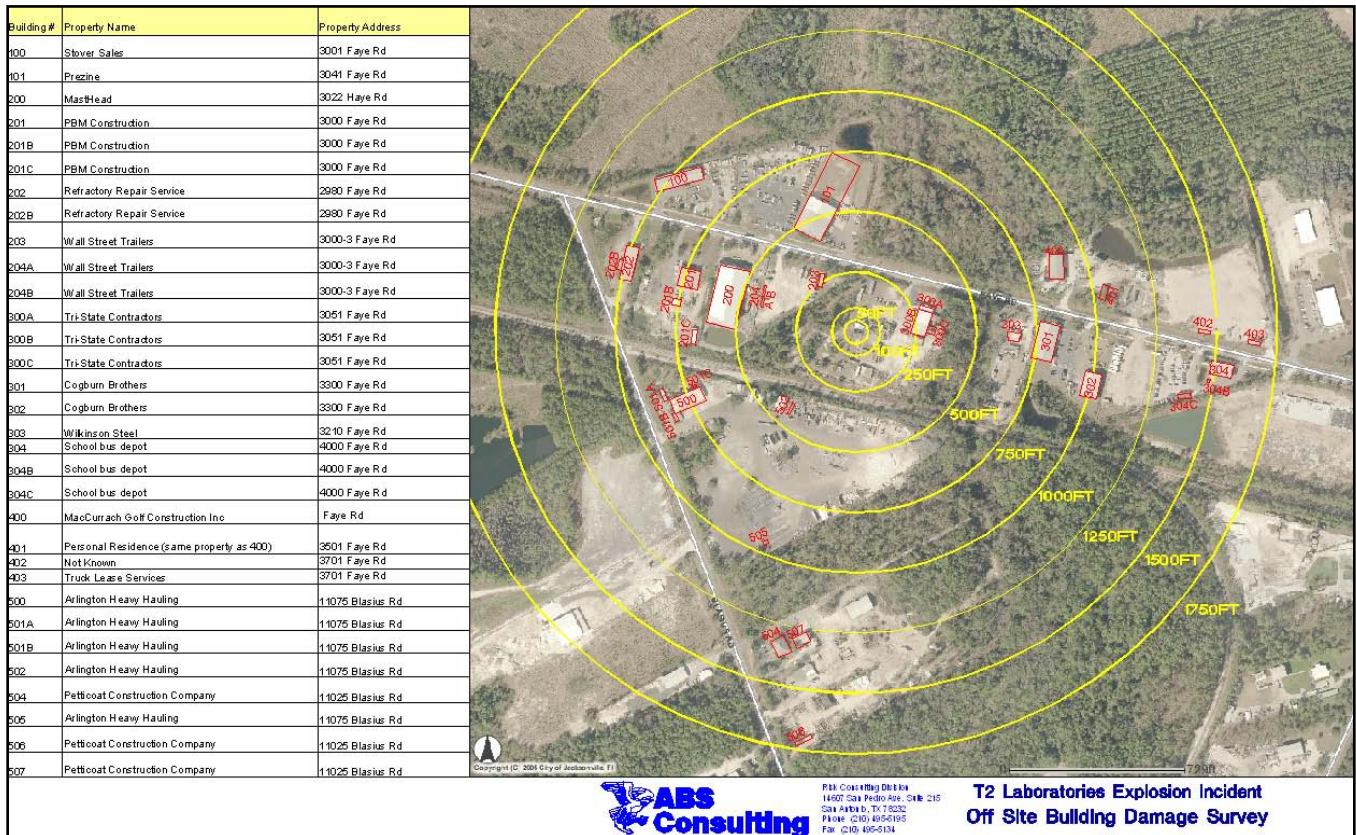
Figure 7. Aerial Site Map of Surveyed Buildings

Figure 7 provides a map of the vicinity surrounding the T2 Laboratories compound as well as a list of buildings surveyed off-site. ABS Consulting surveyed buildings out to a distance where structural damage was no longer observed. This damage extent was approximately 1,750 feet from the explosion source. A total of thirty three (33) buildings were surveyed; buildings included both permanent and portable buildings. A building list with property address and construction type is given in Table 1.

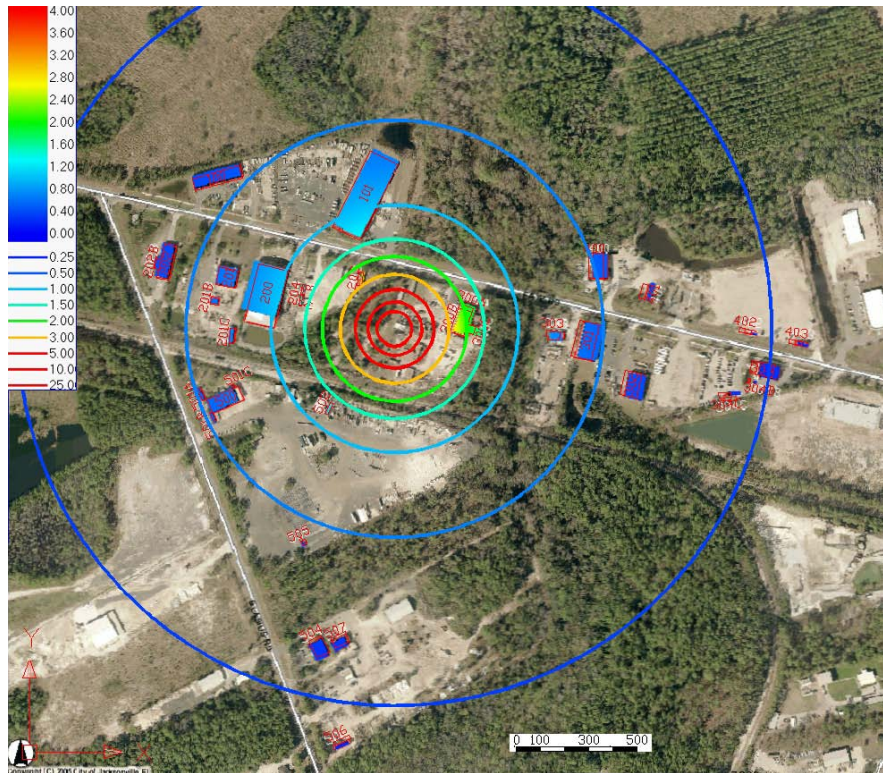
Figure 8. Free-Field Pressure Contours for Estimated TNT Yield of Explosion

The estimated TNT yield of the December 19 explosion at T2 Laboratories was obtained by averaging the estimated yields obtained from each data set and was determined to be approximately 1,400 lb_{TNT} as shown below in Table 2. Free field pressure and impulse contours are provided in Figure 8 and Figure 9 respectively.

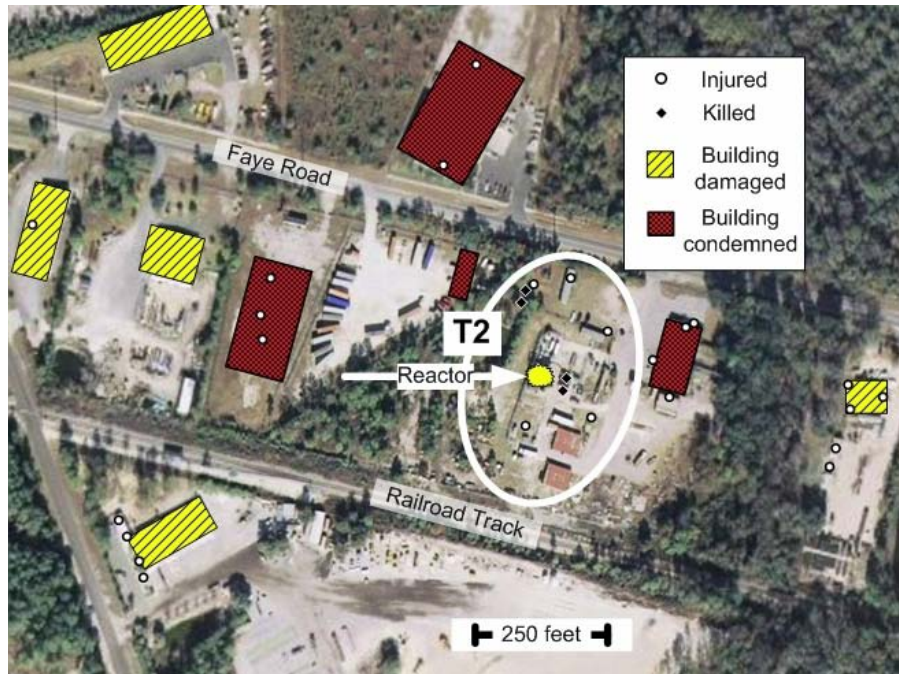
Figure 10. Injury Map^[1]

The explosion killed four T2 employees and injured 32 workers at T2 and surrounding businesses. All of the people at T2 during the incident—eight T2 employees and one truck driver making a delivery—were injured or killed. Four T2 employees died of blunt force trauma as a result of the explosion and one was critically injured and hospitalized for several months. The CSB conducted a community survey of the surrounding businesses to characterize injuries and structure damage (Figure 10). At the nine businesses within 1,900 feet of the reactor, the explosion injured 27 workers. Of those, 11 suffered lacerations and contusions, seven reported hearing loss, and five fell or were thrown by the force of the blast. A summary of the injury and fatality statistics are provided in Table 3 and details of the injuries as recorded by the CSB are provided in Table 4.

A summary of the injury statistics is presented in Table 3. Four T2 Laboratories personnel were fatally injured as a result of the explosion. Notably, two of the fatalities occurred inside of the masonry Control Room.

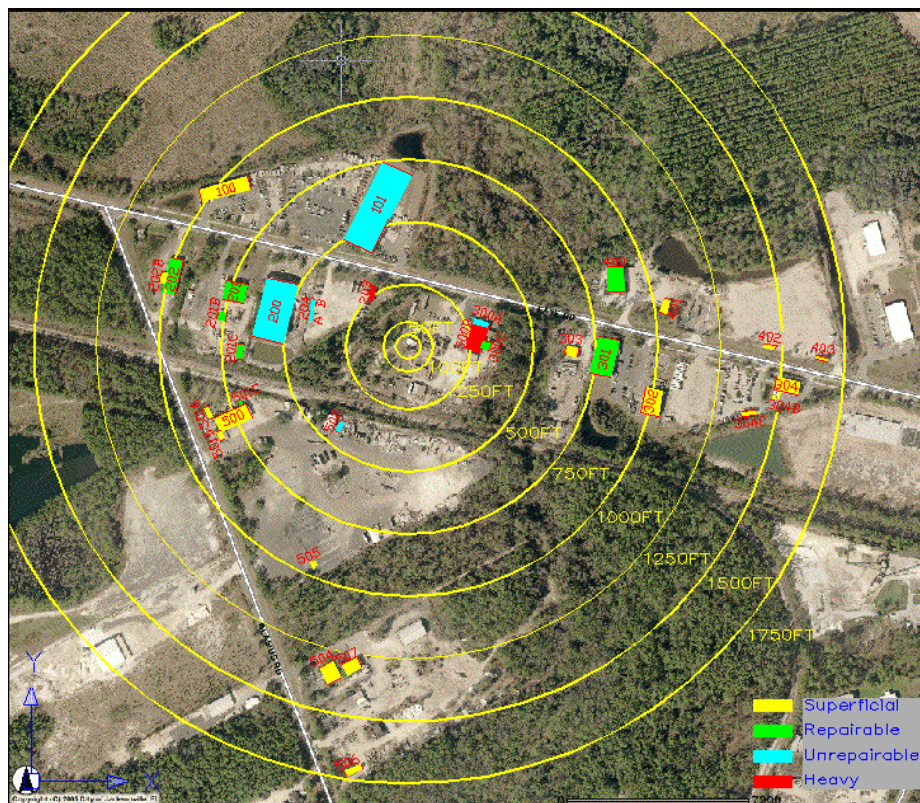
Figure 12. Map of SBEDS Qualitative Building Damage

Building damage levels were assigned to each building based on observed and measured damage and are summarized in Table 7. A graphical map showing ERASDAC and SBEDS qualitative building damage levels is given in Figure 11 and Figure 12, respectively. Side walls and back walls which were significantly deformed outward due to blast loads entering the building envelope through large roll-up doors were not considered in evaluating building damage levels. This is because the methodologies utilized are for assessing buildings subjected to external blast loading. Inspection of Table 7 shows that

the potential exists to cause structural damage well beyond K40 separation. Two large pre-engineered warehouses (Buildings 101 and 200) located at K50 were condemned as a result of the explosion.

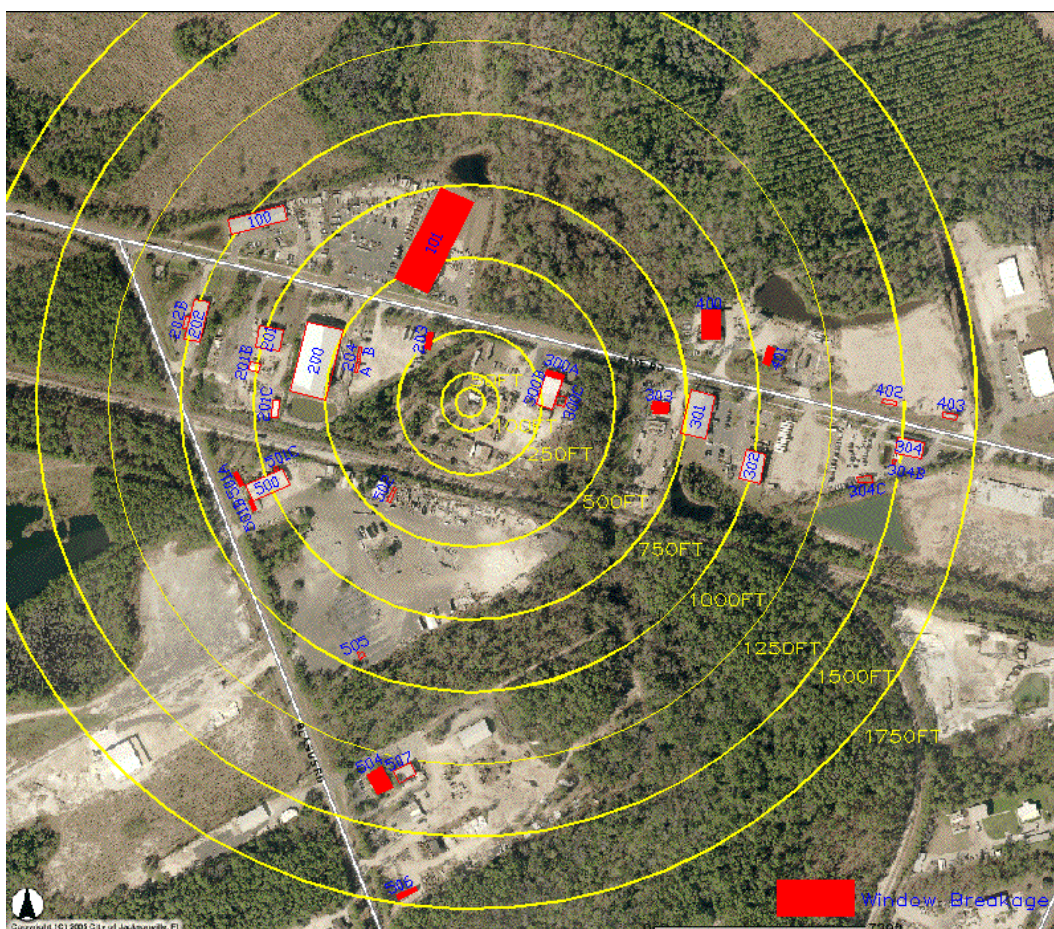
Figure 13. Map of Off-Site Window Breakage

ABS Consulting surveyed windows which broke in the incident up to the structural damage extent at 1,750 feet. A map detailing buildings with observed window breakage is shown below in Figure 13.

Fragment travel of broken glazing is used to quantify the window performance condition in accordance with the Interagency Security Committee (ISC) criteria^[7] which have been adopted by the General Services Administration (GSA) and implemented in the computer software WINGARD (Window Glazing Analysis Response and Design)^[8]. ISC glazing performance conditions are described for each hazard condition in Table 8. Table 9 details the maximum hazard level observed for each building with windows. In many instances the windows had been repaired or replaced prior to inspection by ABS Consulting; however, occupants testified to which windows had broken and the extent of the window fragment travel. Table 9 shows that high hazard level (Level 5) was observed at K50, Medium Hazard Level (Level 4) was observed at up to K75 and that window damage was observed at over K100.

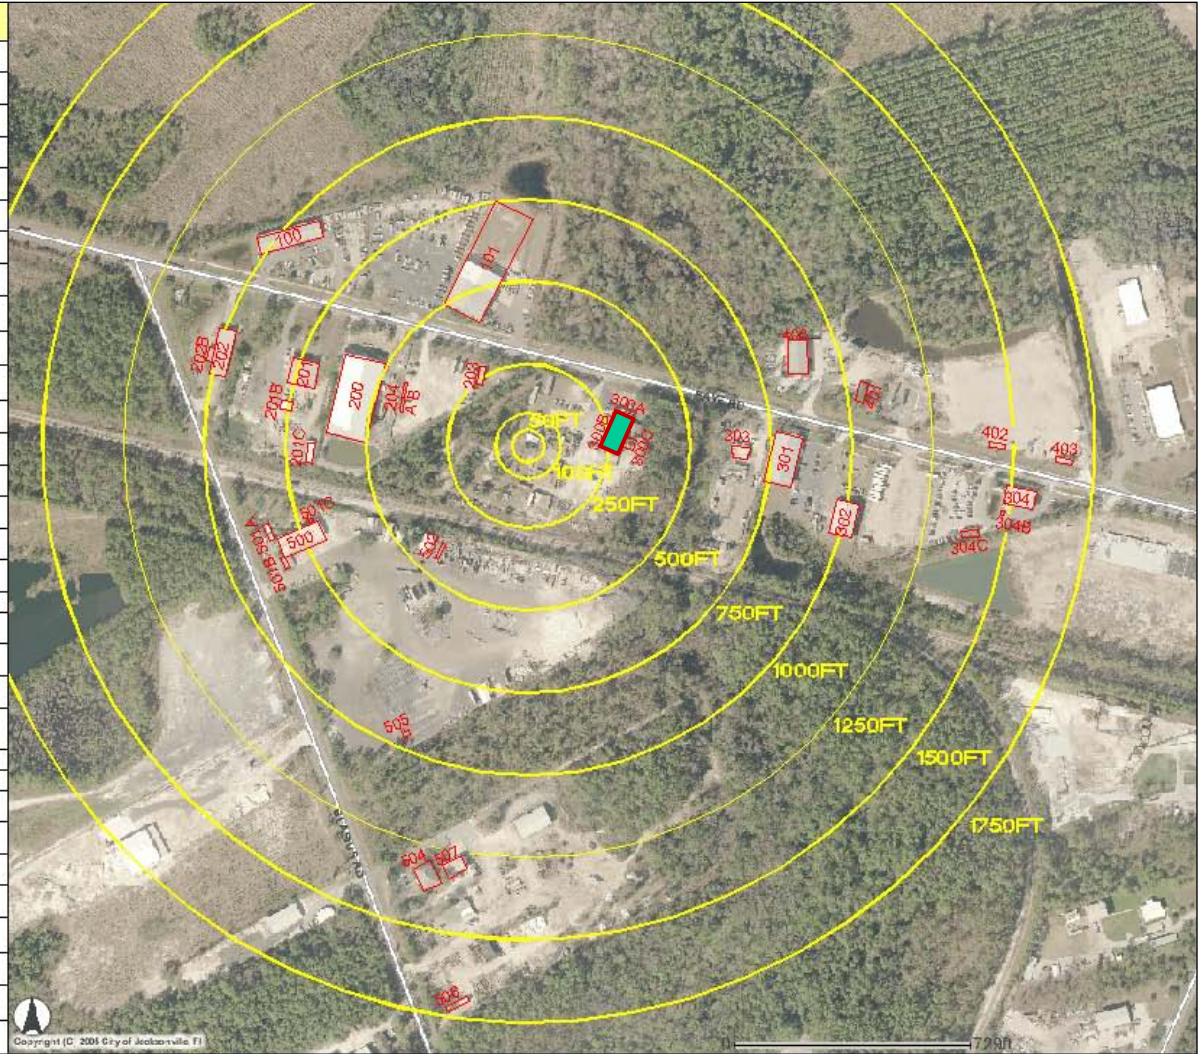
Example Building Damage Building 300 (K25)

- ERASDAC BDL 3
- SBEDS Heavy Damage

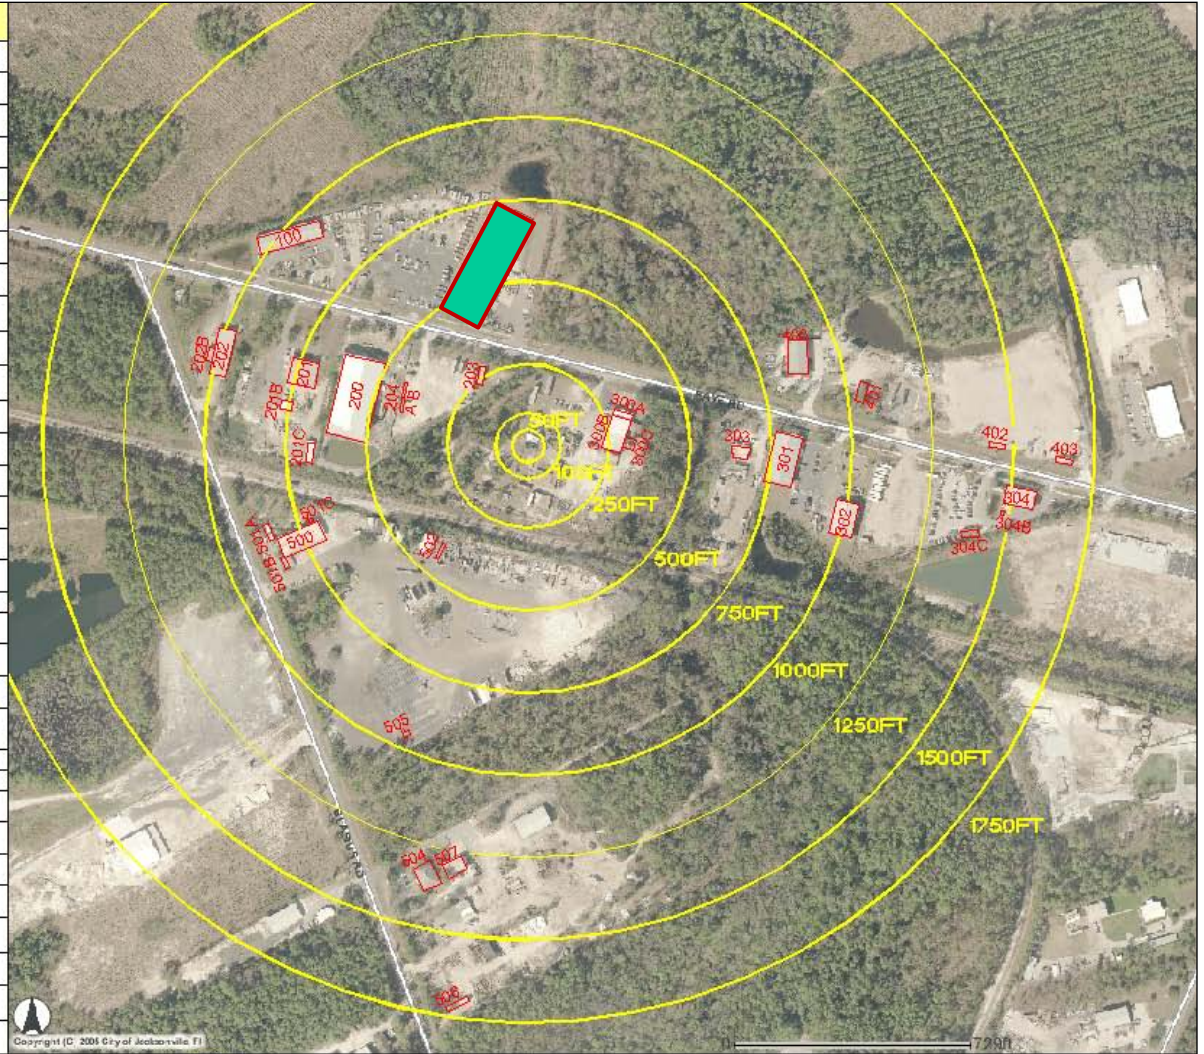
Example Window Damage Building 101 (K50)

Hazard Level 5

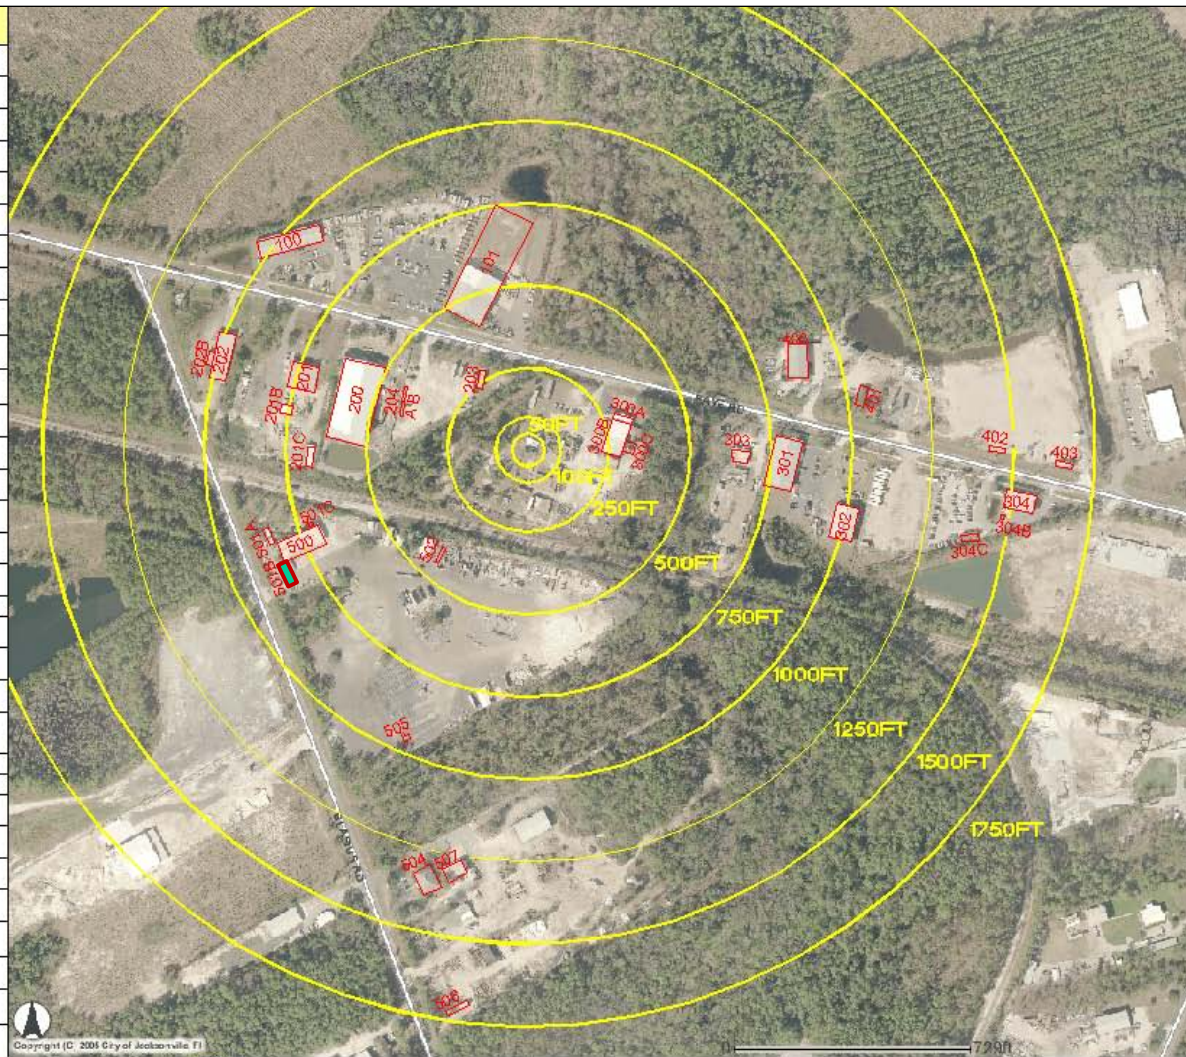
Example Window Damage Building 501B (K75)

Hazard Level 4
